LIMITED ULTRASONOGRAPHIC EXAMINATION

INTERPRETATION OF THE FINDINGS & FURTHER RECOMMENDATIONS

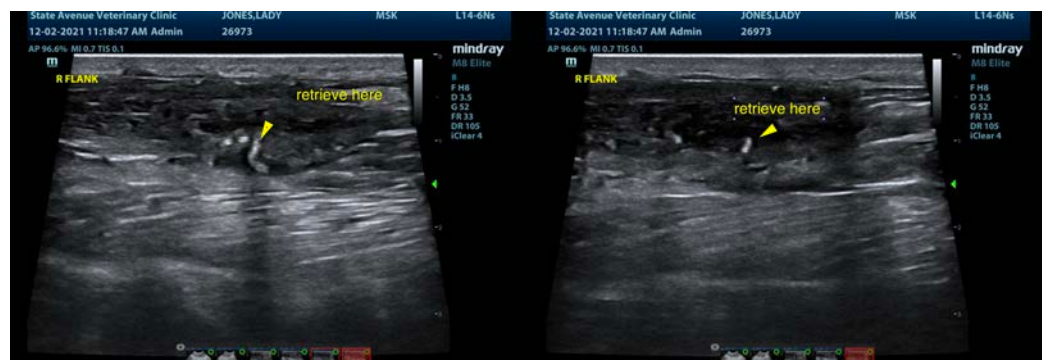
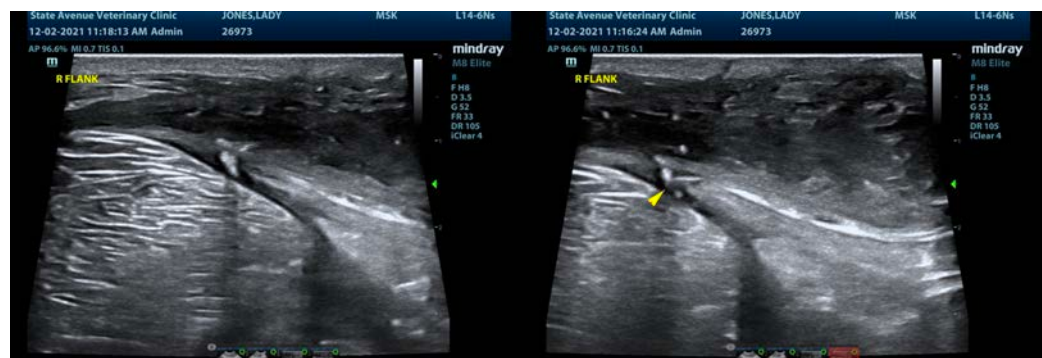
The right flank revealed a mixed hypoechoic subcutaneous lesion with areas of cavitation. The lesion measured approximately 3.0 cm in length x 1.5 cm maximum depth. It appears potentially resectable. However, the margins are ill-defined. It appears to be extending through the fascia. No overt foreign bodies noted. However, foreign matter cannot be completely ruled out. An ulcerative hyperechoic change was noted in the deep portion of the lesion, adjacent to the muscle belly.

Ultrasound guided drainage of the lesion, culture and sensitivity, and FNA of the parenchymal portions warranted. However, exploratory surgery would likely be in the best interest of this patient with resection down to the level of the muscle belly. The hyperechoic linear structure at the middle aspect of the lesion should be investigated at surgery for potential penetrating foreign structure. Otherwise, attempt at ultrasound guided retrieval of the hyperechoic structure could be considered to assess if this is a residual fox tail or similar material. The depth of the structure is approximately 1.5 cm. Ultrasound guided surgical intervention to this specific region could also be considered. This is unlikely to be neoplastic. Likely abscessation owing to foreign matter or other causes.
