9/21/21 History: Post-operative neo-ureterostomy (and castration) on 8/24/2021
Diagnosed with right ectopic ureter and right hydronephrosis.

LIMITED ULTRASONOGRAPHIC EXAMINATION**Urinary System**

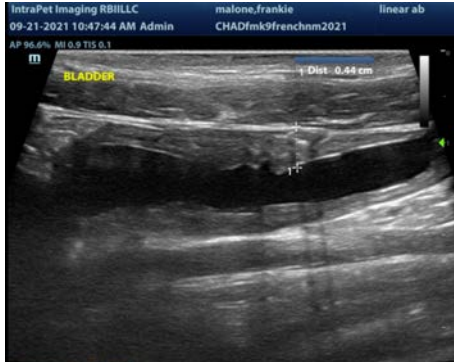
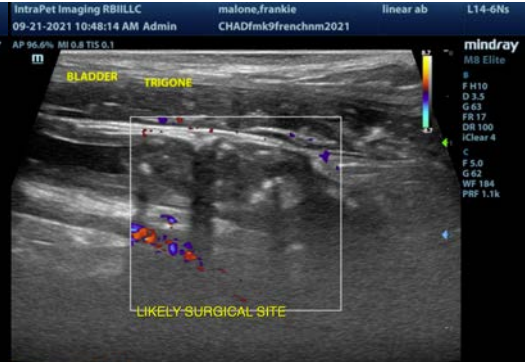
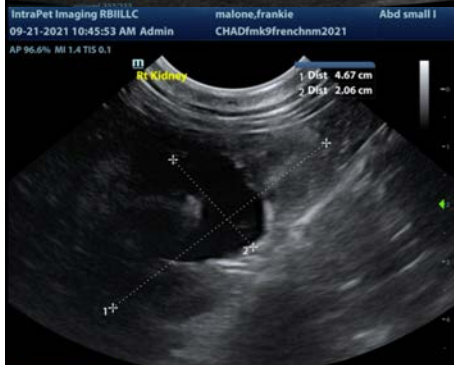
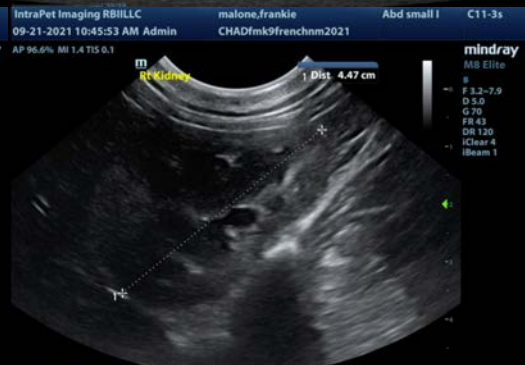
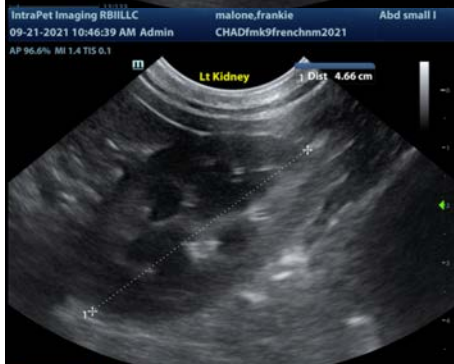
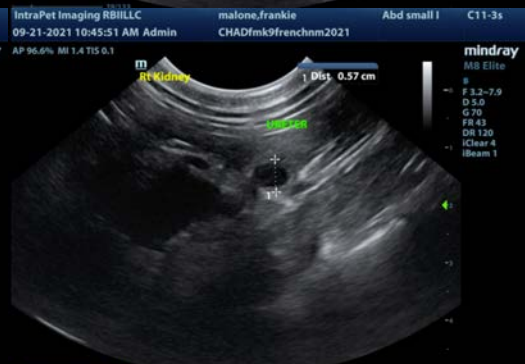
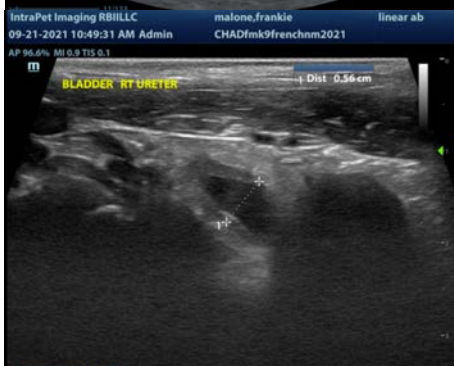
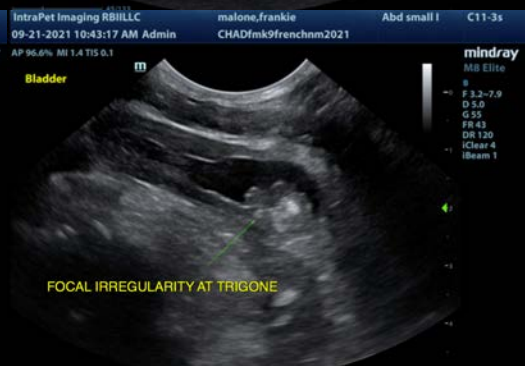
The urinary bladder is minimally distended with anechoic urine. The Bladder wall is somewhat irregular with shadowing material in areas, most consistent with suture material. The trigone area is thickened and irregular in an area spanning approximately 2.23 cm x 0.99 cm, most consistent with a previous surgical site. There is minor irregularity and suture material seen along the ventral midline, likely at the previous cystotomy site. The left ureter is not visualized. The right ureter is visualized and is dilated at the level of the urinary bladder at 0.56 cm. This is similar to previous measurements. No cystic calculi were observed.

The left kidney has a normal shape and size (4.66 cm). Overall echogenicity is normal with adequate corticomedullary distinction and a typical 1:3 cortex:medulla ratio. There is no evidence of perinephric inflammation or effusion. There is no evidence of pyelectasia, nephroliths, infarcts or hydroureter. Renal vasculature is normal.

The right kidney is normal in size and shape, measuring 4.67 cm (less globoid than previous scan). The renal pelvis measures approximately 2.06 cm and is dilated, but improved from previous measurements at 3.8 cm. The proximal ureter is dilated at measures at 0.51 cm. This is similar to previous measurements.

- Right-sided hydronephrosis and hydroureter – There is significant improvement from the last scan, but persistent (likely permanent) changes are visualized.
- Irregular bladder wall – most consistent with two surgical sites, one at the trigone and the other at the ventral midline location.

The right kidney appears much less turgid and obstructed on today's scan. Based on the surgical report, the ureter was minimally patent, causing the hydronephrosis/hydroureter. This appears improved, but the dilation persists, as is often the case and will likely be permanent. This will post increased risk for pyelonephritis and infection. Therefore, frequent monitoring is warranted.

Additionally, the urinary bladder wal (particularly at the trigone) is very irregular. This is consistent with the surgical site location, and we should see improvement as suture is resorbed and healing takes place. Periodic monitoring of this area is warranted to look for stricture formation, which would likely occur within the first year post-op. Additionally, if at all possible, evaluation of the urinary bladder with more distention would be helpful. Recommend periodic urinalysis and culture. Recommend repeat ultrasound of this area in 2-4 months, as long as the patient is doing clinically well.
